**Flood Control Project Maintenance  
Levee Inspections**

## Maintenance Issue Types Only, Levee Inspection Report By Mile - Fall 2015

### Tehama County Flood Control and Water Conservation District

Waterway	Bank	Unit Miles	Inspection Start/End	Inspector
Unit No. 01 Deer Creek	Left	4.22	09/24/2015 09/24/2015	Bob Duffey

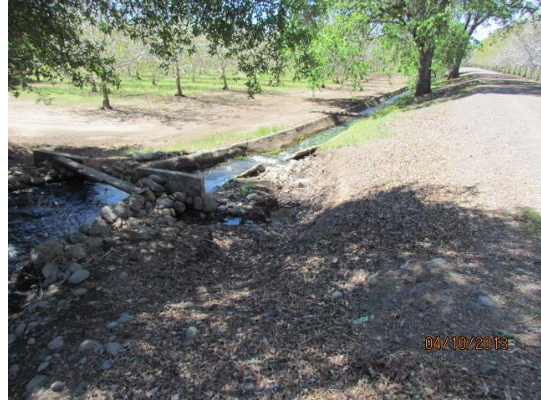
Photo 1 of 1 : FA\_2015\_NA0019\_78\_17\_20150910\_00009.jpg

LM Start	0.01	Rating **	M	Issue No.	17
LM End	0.01	Issue Type +	Ma	Location *	LS
Category	Earthen Levee			GPS Latitude/Longitude	
				Start	End
Item	Erosion / Bank Caving			39.973111 °	39.973111 °
				-121.980466 °	-121.980466 °
DWR ID	DWR_NA0019_01_s_2013_17				
Action/Comments					
Note and monitor erosion site.

View of the erosion along the landside slope.

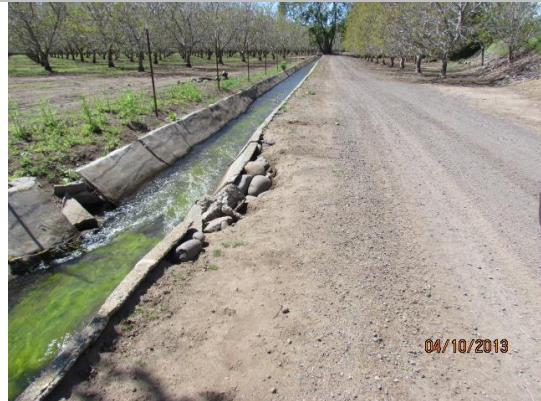
Photo 1 of 1 : FA\_2015\_NA0019\_78\_18\_20150910\_00010.jpg

LM Start	0.41	Rating **	M	Issue No.	18
LM End	0.41	Issue Type +	Ma	Location *	LS
Category	Earthen Levee			GPS Latitude/Longitude	
				Start	End
Item	Erosion / Bank Caving			39.972560 °	39.972560 °
				-121.987759 °	-121.987759 °
DWR ID	DWR_NA0019_01_s_2013_18				
Action/Comments					
Note and monitor erosion site.

View of the erosion along the landside slope.

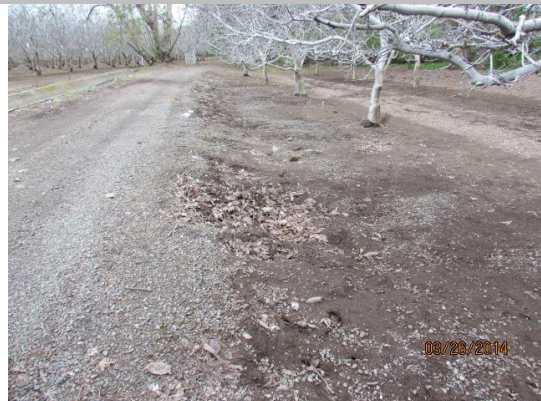
Photo 1 of 1 : FA\_2015\_NA0019\_78\_276\_20150910\_00017.jpg

LM Start	0.45	Rating **	M	Issue No.	276
LM End	0.45	Issue Type +	Ma	Location *	WS
Category	Earthen Levee			GPS Latitude/Longitude	
				Start	End
Item	Slope Stability			39.972377 °	39.972377 °
				-121.988559 °	-121.988559 °
DWR ID	DWR_NA0019_01_s_2014_276				
Action/Comments					
Repair slope instability.

View of the erosion along the waterside slope.

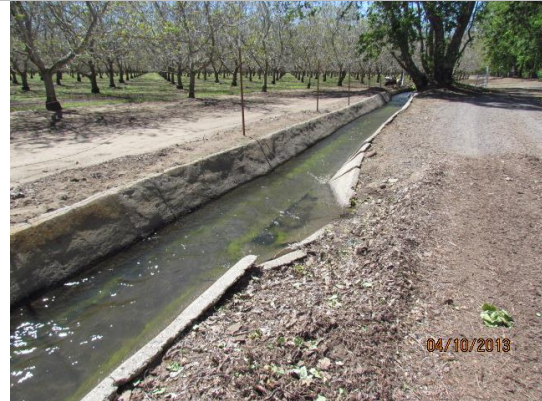
Photo 1 of 1 : FA\_2015\_NA0019\_78\_19\_20150910\_00011.jpg

LM Start	0.46	Rating **	M	Issue No.	19
LM End	0.46	Issue Type +	Ma	Location *	LS
Category	Earthen Levee			GPS Latitude/Longitude	
				Start	End
Item	Erosion / Bank Caving			39.972339 °	39.972339
				-121.988763 °	-121.988763
DWR ID	DWR_NA0019_01_s_2013_19				
Action/Comments					
Note and monitor erosion site.

View of the erosion along the landside slope.

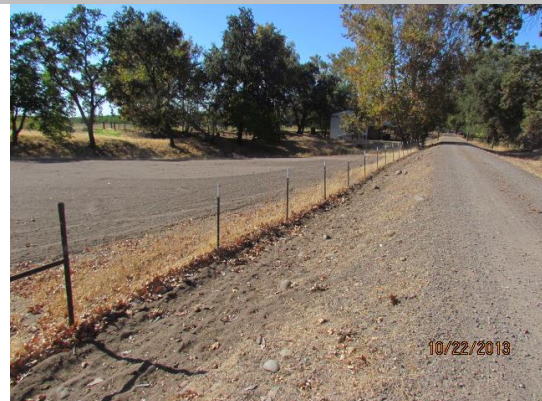
Photo 1 of 1 : FA\_2015\_NA0019\_78\_21\_20150910\_00013.jpg

LM Start	1.52	Rating **	M	Issue No.	21
LM End	1.52	Issue Type +	Ma	Location *	LS
Category	Earthen Levee			GPS Latitude/Longitude	
				Start	End
Item	Animal Control			39.969419 °	39.969419 °
				-122.007850 °	-122.007850 °
DWR ID	DWR_NA0019_01_f_2013_21				
Action/Comments					
Repair the levee slope damaged by livestock and prevent large animal access.

View of the erosion caused by livestock on both slope of the levee.

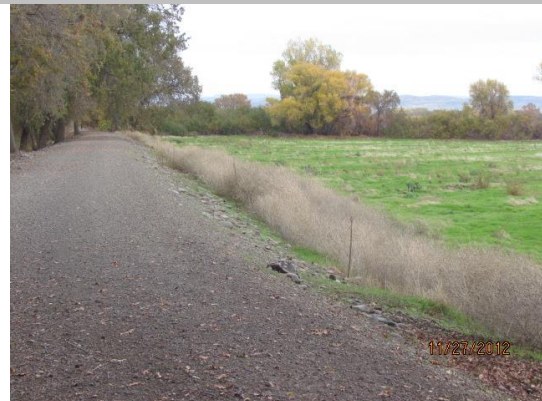
Photo 1 of 1 : FA\_2015\_NA0019\_78\_3\_20150910\_00002.jpg

LM Start	2.29	Rating **	M	Issue No.	3
LM End	3.04	Issue Type +	Ma	Location *	LS
Category	Earthen Levee			GPS Latitude/Longitude	
				Start	End
Item	Vegetation			39.967015 °	°
				-122.020781 °	°
DWR ID	DWR_NA0019_01_f_2012_3				
Action/Comments					
Remove the wild growth other than native grasses from the levee slopes.

View of the vegetation along the landside slope.

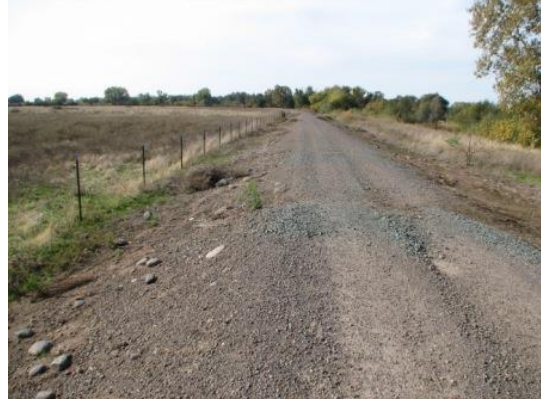
Photo 1 of 1 : FA\_2015\_NA0019\_78\_8\_20150910\_00003.jpg

LM Start	2.70	Rating **	M	Issue No.	8
LM End	2.73	Issue Type +	Ma	Location *	CR
Category	Earthen Levee			GPS Latitude/Longitude	
				Start	End
Item	Slope Stability			39.965434 °	39.965180 °
				-122.027776 °	-122.028331 °
DWR ID	DWR_NA0019_01_s _ 2012_8				
Action/Comments					
Repair the levee slope damaged by foot traffic and prevent access where possible.

Erosion on crown and both slopes.

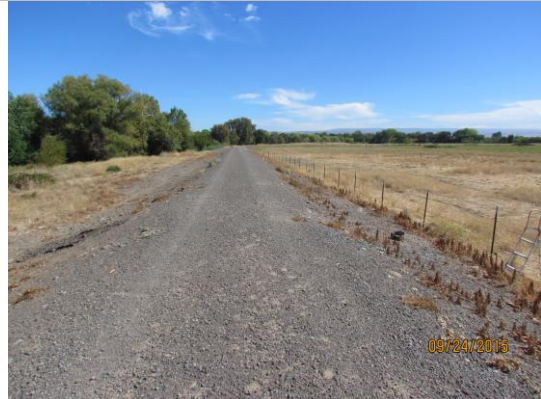
Photo 1 of 1 : FA\_2015\_NA0019\_78\_40\_20151012\_00029.jpg

LM Start	2.71	Rating **	A	Issue No.	40
LM End	2.71	Issue Type +	Ma	Location *	LS
Category	Earthen Levee			GPS Latitude/Longitude	
				Start	End
Item	Vegetation			39.965367 °	39.965367 °
				-122.027955 °	-122.027955 °
DWR ID	DWR_NA0019_01_f _ 2015_40				
Action/Comments					
Control annual grass and weeds on the levee slopes and easements. Inspector Comments: Tehama Co. sprayed both slopes to remove all vegetation.

View of the no vegetation on both slopes.

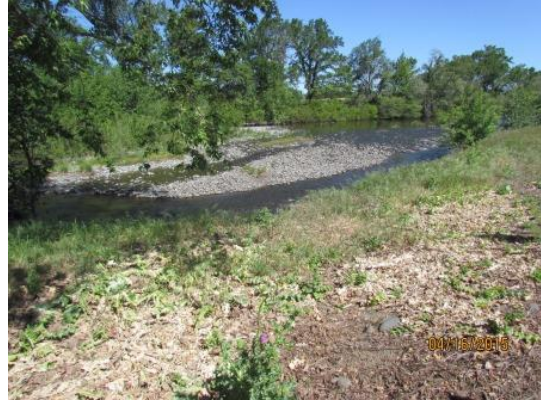
Photo 1 of 1 : FA\_2015\_NA0019\_78\_39\_20150910\_00015.jpg

LM Start	2.78	Rating **	M	Issue No.	39
LM End	2.78	Issue Type +	Ma	Location *	WS
Category	Earthen Levee			GPS Latitude/Longitude	
				Start	End
Item	Erosion / Bank Caving			39.964772 °	39.964772 °
				-122.029023 °	-122.029023 °
DWR ID	DWR_NA0019_01_s_2015_39				
Action/Comments					
Note and monitor erosion site.					
Inspector Comments: Monitor the erosion during high water.

View of the erosion along the waterside toe.

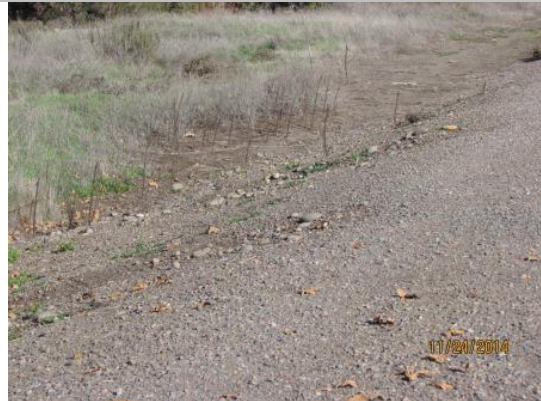
Photo 1 of 1 : FA\_2015\_NA0019\_78\_38\_20150910\_00014.jpg

LM Start	2.86	Rating **	M	Issue No.	38
LM End	2.86	Issue Type +	Ma	Location *	LS
Category	Earthen Levee			GPS Latitude/Longitude	
				Start	End
Item	Slope Stability			39.963928 °	39.963928 °
				-122.030120 °	-122.030120 °
DWR ID	DWR_NA0019_01_f_2014_38				
Action/Comments					
Repair slope instability.

View of erosion from the cattle on both slopes.

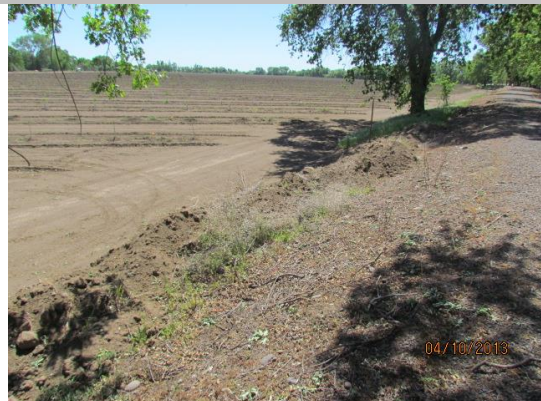
Photo 1 of 1 : FA\_2015\_NA0019\_78\_20\_20150910\_00012.jpg

LM Start	2.88	Rating **	M	Issue No.	20
LM End	2.88	Issue Type +	Ma	Location *	LS
Category	Earthen Levee			GPS Latitude/Longitude	
				Start	End
Item	Slope Stability			39.963709 °	39.963709
				-122.030384 °	-122.030384
DWR ID	DWR_NA0019_01_s_2013_20				
Action/Comments					
Repair slope instability.

View of the erosion along the landside slope.

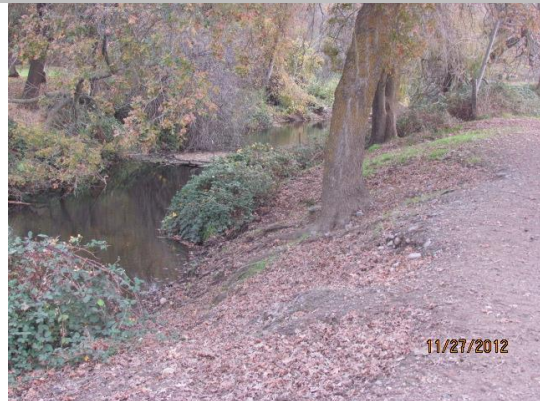
Photo 1 of 1 : FA\_2015\_NA0019\_78\_15\_20150910\_00007.jpg

LM Start	3.68	Rating **	M	Issue No.	15
LM End	3.68	Issue Type +	Ma	Location *	WS
Category	Earthen Levee			GPS Latitude/Longitude	
				Start	End
Item	Slope Stability			39.945045 °	39.945045 °
				-122.053469 °	-122.053469 °
DWR ID	DWR_NA0019_01_f_2012_15				
Action/Comments					
Repair slope instability.

View of the erosion caused by livestock along the landside slope.

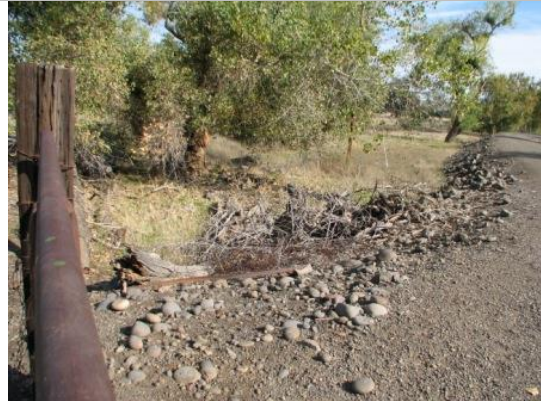
Photo 1 of 1 : FA\_2015\_NA0019\_79\_2\_20150910\_00001.jpg

LM Start	0.30	Rating **	M	Issue No.	2
LM End	0.30	Issue Type +	Ma	Location *	LS
Category	Earthen Levee			GPS Latitude/Longitude	
				Start	End
Item	Encroachments			39.970305 °	39.970305
				-122.014465 °	-122.014465
DWR ID	DWR_NA0019_02_s_2012_2				
Action/Comments					
Debris

View of debris &amp; wire at toe of levee.

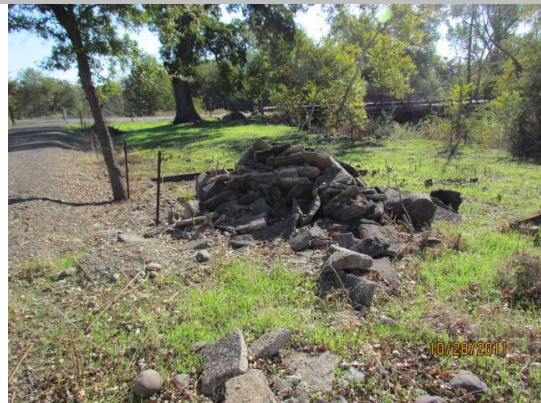
Photo 1 of 1 : FA\_2015\_NA0019\_79\_4\_20150910\_00003.jpg

LM Start	0.34	Rating **	M	Issue No.	4
LM End	0.34	Issue Type +	Ma	Location *	WS
Category	Earthen Levee			GPS Latitude/Longitude	
				Start	End
Item	Encroachments			39.970210 °	39.970210 °
				-122.015198 °	-122.015198 °
DWR ID	DWR_NA0019_02_s_2012_4				
Action/Comments					
Debris

View of the concrete pile along the W/S toe.

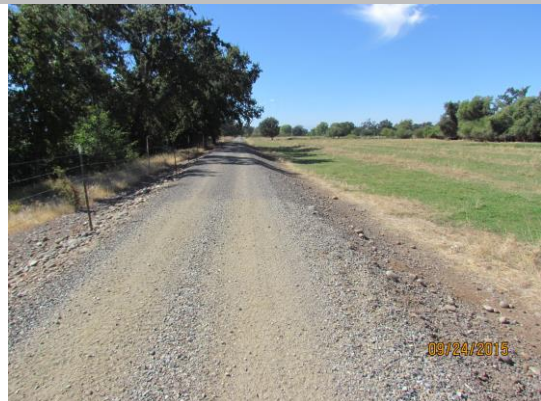
Photo 1 of 1 : FA\_2015\_NA0019\_79\_11\_20151012\_00007.jpg

LM Start	0.85	Rating **	A	Issue No.	11
LM End	0.85	Issue Type +	Ma	Location *	LS
Category	Earthen Levee			GPS Latitude/Longitude	
				Start	End
Item	Vegetation			39.968290 °	39.968290 °
				-122.023860 °	-122.023860 °
DWR ID	DWR_NA0019_02_f_2015_11				
Action/Comments					
Control annual grass and weeds on the levee slopes and easements. Inspector Comments: Tehama Co. sprayed both slopes to remove the vegetation.

View of no Vegetation on both slopes.

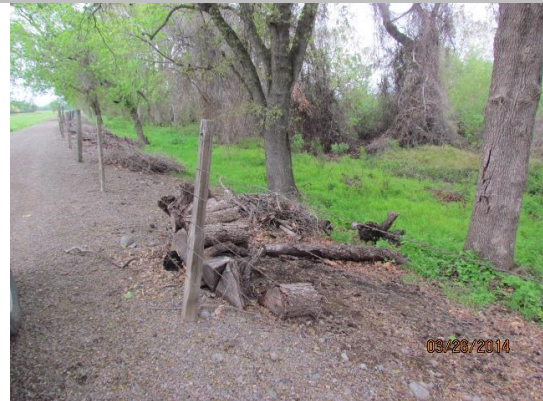
Photo 1 of 1 : FA\_2015\_NA0019\_79\_6\_20150910\_00004.jpg

LM Start	1.28	Rating **	M	Issue No.	6
LM End	1.28	Issue Type +	Ma	Location *	WS
Category	Earthen Levee			GPS Latitude/Longitude	
				Start	End
Item	Encroachments			39.964883 °	39.964883 °
				-122.030655 °	-122.030655 °
DWR ID	DWR_NA0019_02_s_2012_6				
Action/Comments					
Firewood

Remove all firewood from the waterside slope.

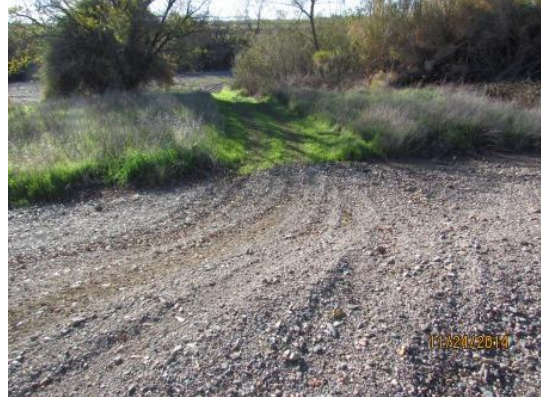
Photo 1 of 1 : FA\_2015\_NA0019\_81\_16\_20150910\_00009.jpg

LM Start	1.39	Rating **	M	Issue No.	16
LM End	1.39	Issue Type +	Ma	Location *	WS
Category	Earthen Levee			GPS Latitude/Longitude	
				Start	End
Item	Slope Stability			40.051493 °	40.051493 °
				-122.164935 °	-122.164935 °
DWR ID	DWR_NA0019_04_f _ 2014_16				
Action/Comments					
Repair the levee slope damaged by vehicle traffic and prevent access where possible.

View of the vehicle erosion along the waterside slope.

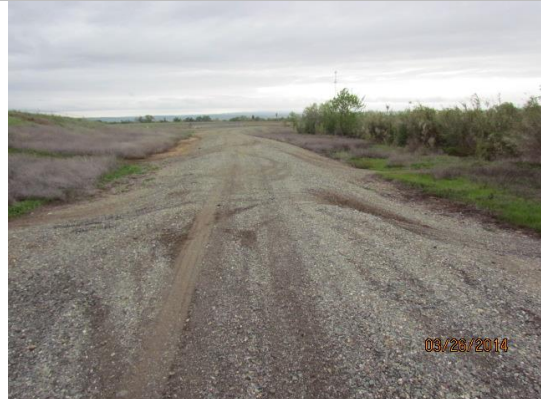
Photo 1 of 1 : FA\_2015\_NA0019\_81\_3\_20150910\_00003.jpg

LM Start	1.59	Rating **	M	Issue No.	3
LM End	1.69	Issue Type +	Ma	Location *	WS
Category	Earthen Levee			GPS Latitude/Longitude	
				Start	End
Item	Slope Stability			40.052607 °	40.053558 °
				-122.161418 °	-122.159903 °
DWR ID	DWR_04_s_2012_3				
Action/Comments					
Repair the levee slope damaged by vehicle traffic and prevent access where possible.					
Inspector Comments: Tehama Co. repaired the slope that was damaged by vehicle traffic, but the damage has returned.

View of the levee slope damaged by vehicle traffic.

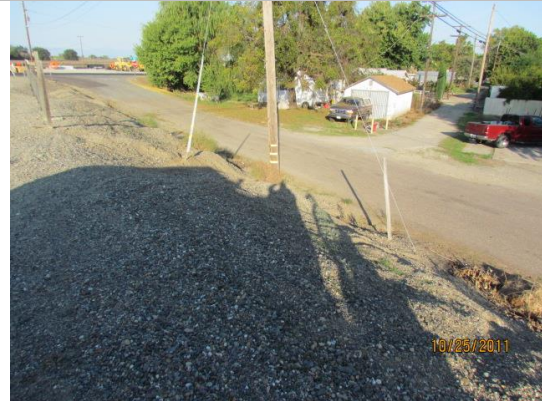
Photo 1 of 1 : FA\_2015\_NA0019\_81\_18\_20150910\_00011.jpg

LM Start	2.30	Rating **	M	Issue No.	18
LM End	2.30	Issue Type +	Ma	Location *	LS
Category	Earthen Levee			GPS Latitude/Longitude	
				Start	End
Item	Slope Stability			40.052415 °	40.052415
				-122.149208 °	-122.149208
DWR ID	DWR_NA0019_04_s_2012_18				
Action/Comments					
Repair the levee slope damaged by vehicle traffic and prevent access where possible.

View of the vehicle erosion along the L/S slope.

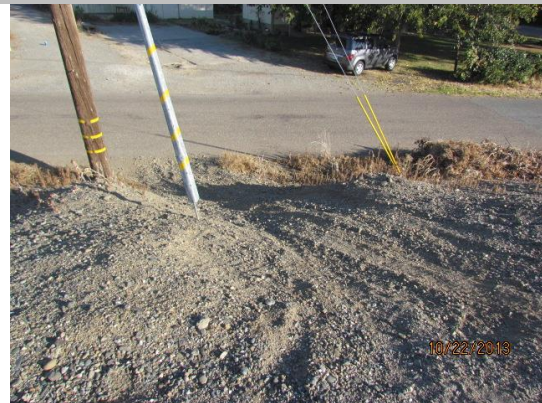
Photo 1 of 1 : FA\_2015\_NA0019\_81\_12\_20150910\_00006.jpg

LM Start	2.32	Rating **	M	Issue No.	12
LM End	2.32	Issue Type +	Ma	Location *	LS
Category	Earthen Levee			GPS Latitude/Longitude	
				Start	End
Item	Slope Stability			40.052443 °	40.052443 °
				-122.148863 °	-122.148863 °
DWR ID	DWR_NA0019_04_f_2013_12				
Action/Comments					
Repair the levee slope damaged by vehicle traffic and prevent access where possible.

View of the vehicle erosion along the landside slope.

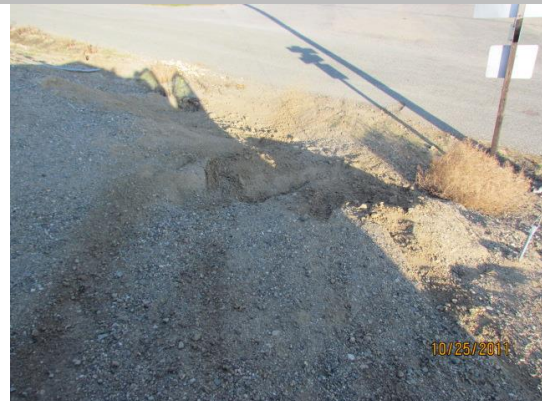
Photo 1 of 1 : FA\_2015\_NA0019\_81\_20\_20150910\_00013.jpg

LM Start	2.43	Rating **	M	Issue No.	20
LM End	2.43	Issue Type +	Ma	Location *	LS
Category	Earthen Levee			GPS Latitude/Longitude	
				Start	End
Item	Slope Stability			40.052417 °	40.052417 °
				-122.146747 °	-122.146747 °
DWR ID	DWR_NA0019_04_s_2012_20				
Action/Comments					
Repair the levee slope damaged by vehicle traffic and prevent access where possible.

View of the vehicle erosion along the L/S slope.

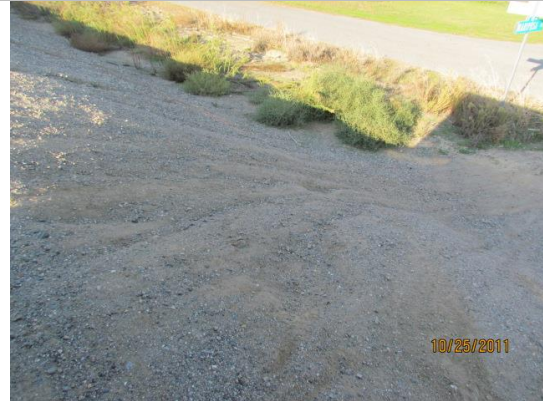
Photo 1 of 1 : FA\_2015\_NA0019\_81\_2\_20150910\_00002.jpg

LM Start	2.51	Rating **	M	Issue No.	2
LM End	2.51	Issue Type +	Ma	Location *	LS
Category	Earthen Levee			GPS Latitude/Longitude	
				Start	End
Item	Slope Stability			40.052872 °	40.052872 °
				-122.145495 °	-122.145495 °
DWR ID	DWR_NA0019_04_s _ 2012_2				
Action/Comments					
Repair the levee slope damaged by vehicle traffic and prevent access where possible.

View of the vehicle erosion along the L/S slope.

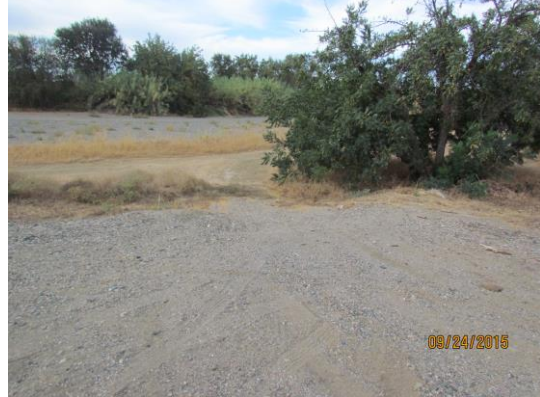
Photo 1 of 1 : FA\_2015\_NA0019\_81\_10\_20151012\_00022.jpg

LM Start	3.01	Rating **	M	Issue No.	10
LM End	3.01	Issue Type +	Ma	Location *	WS
Category	Earthen Levee			GPS Latitude/Longitude	
				Start	End
Item	Slope Stability			40.056388 °	40.056388 °
				-122.139168 °	-122.139168 °
DWR ID	DWR_NA0019_04_s _ 2012_10				
Action/Comments					
Repair the levee slope damaged by vehicle traffic and prevent access where possible.					
Inspector Comments: Repair the waterside slope from vehicle erosion.

View of the vehicle erosion along the waterside slope.

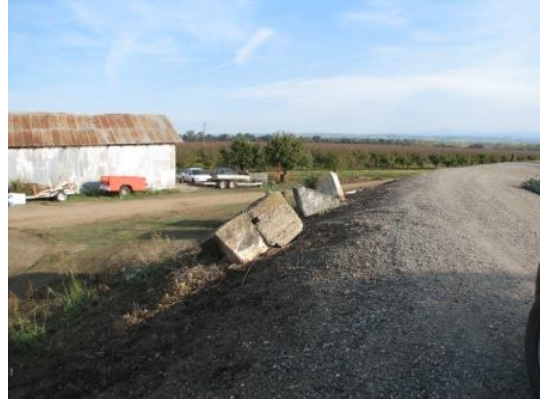
Photo 1 of 1 : FA\_2015\_NA0019\_81\_1\_20150910\_00001.jpg

LM Start	3.13	Rating **	M	Issue No.	1
LM End	3.13	Issue Type +	Ma	Location *	LS
Category	Earthen Levee			GPS Latitude/Longitude	
				Start	End
Item	Encroachments			40.057285 °	40.057285 °
				-122.137732 °	-122.137732 °
DWR ID	DWR_NA0019_04_s _ 2012_1				
Action/Comments					
Stairway					
Inspector Comments: Remove the stairs from the landside slope.

View of the concrete stairways on the slope.

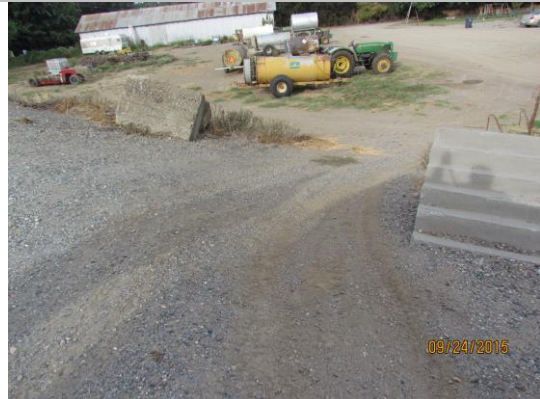
Photo 1 of 1 : FA\_2015\_NA0019\_81\_25\_20151012\_00023.jpg

LM Start	3.13	Rating **	M	Issue No.	25
LM End	3.13	Issue Type +	Ma	Location *	LS
Category	Earthen Levee			GPS Latitude/Longitude	
				Start	End
Item	Slope Stability			40.057350 °	40.057350 °
				-122.137667 °	-122.137667 °
DWR ID	DWR_NA0019_04_f _ 2015_25				
Action/Comments					
Repair the levee slope damaged by vehicle traffic and prevent access where possible.					
Inspector Comments: Repair the landside slope from vehicle erosion.

View of the vehicle erosion along the landside slope.

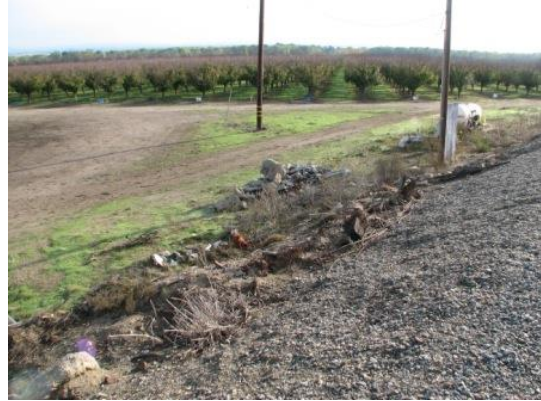
Photo 1 of 1 : FA\_2015\_NA0019\_81\_6\_20150910\_00004.jpg

View of the garbage and metal along the landside slope and toe of the levee.

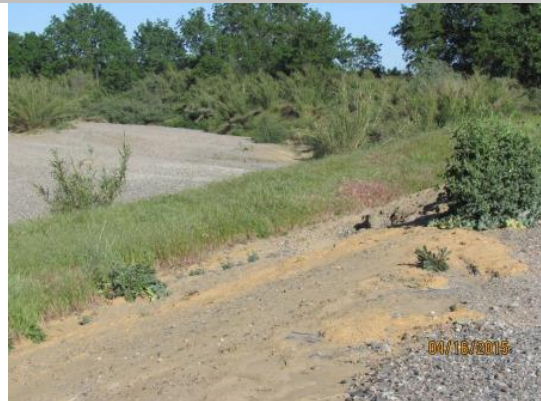
Photo 1 of 1 : FA\_2015\_NA0019\_81\_23\_20150910\_00016.jpg

LM Start	3.78	Rating **	U	Issue No.	23
LM End	3.89	Issue Type +	Ma	Location *	WS
Category	Earthen Levee			GPS Latitude/Longitude	
				Start	End
Item	Erosion / Bank Caving			40.055207 °	40.054225 °
				-122.127735 °	-122.126085 °
DWR ID	DWR_NA0019_04_s _ 2015_23				
Action/Comments					
Schedule repair of erosion site prior to the next inspection.					
Inspector Comments: Repair the erosion along the waterside slope.

View of the erosion along the waterside slope.

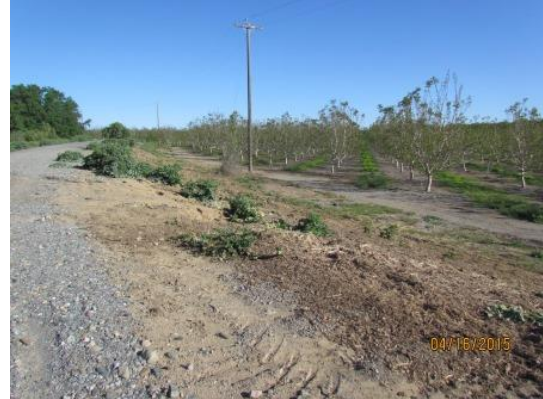
Photo 1 of 1 : FA\_2015\_NA0019\_81\_22\_20150910\_00015.jpg

LM Start	3.78	Rating **	U	Issue No.	22
LM End	3.93	Issue Type +	Ma	Location *	LS
Category	Earthen Levee			GPS Latitude/Longitude	
				Start	End
Item	Erosion / Bank Caving			40.055162 °	40.053915 °
				-122.127713 °	-122.125412 °
DWR ID	DWR_NA0019_04_s _ 2015_22				
Action/Comments					
Schedule repair of erosion site prior to the next inspection.					
Inspector Comments: Repair the erosion along the landside slope.

View of the erosion along the landside slope.

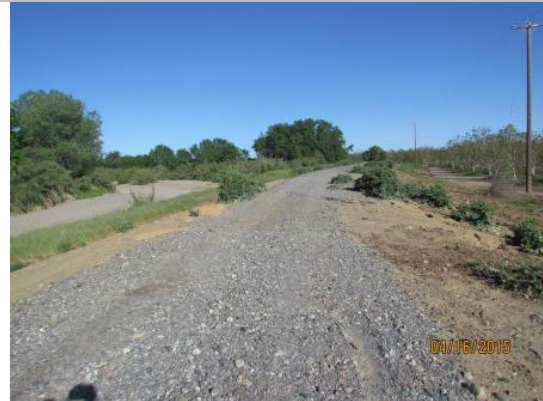
Photo 1 of 1 : FA\_2015\_NA0019\_81\_24\_20150910\_00017.jpg

LM Start	3.79	Rating **	U	Issue No.	24
LM End	3.93	Issue Type +	Ma	Location *	CR
Category	Earthen Levee			GPS Latitude/Longitude	
				Start	End
Item	Erosion / Bank Caving			40.055060 °	40.053917 °
				-122.127602 °	-122.125412 °
DWR ID	DWR_NA0019_04_s _ 2015_24				
Action/Comments					
Schedule repair of erosion site prior to the next inspection.					
Inspector Comments: Repair the erosion on the crown roadway.

View of the erosion on the crown roadway.

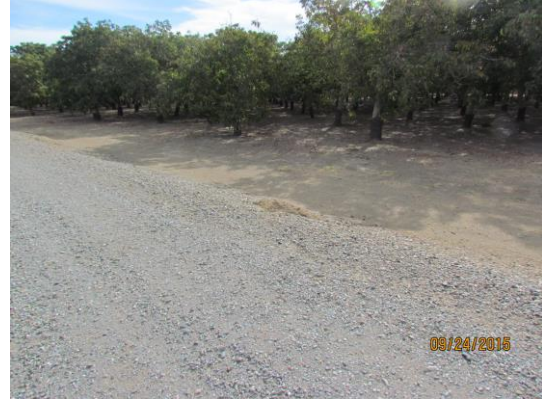
Photo 1 of 1 : FA\_2015\_NA0019\_82\_8\_20151012\_00010.jpg

View of the rodent holes along the landside slope.

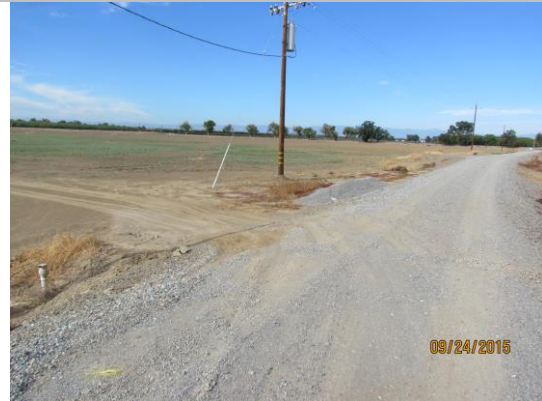
Photo 1 of 1 : FA\_2015\_NA0019\_82\_13\_20151012\_00011.jpg

LM Start	1.51	Rating **	M	Issue No.	13
LM End	1.51	Issue Type +	Ma	Location *	LS
Category	Earthen Levee			GPS Latitude/Longitude	
				Start	End
Item	Slope Stability			40.050653 °	40.050653
				-122.165495 °	-122.165495
DWR ID	DWR_NA0019_05_f_2015_13				
Action/Comments					
Repair the levee slope damaged by vehicle traffic and prevent access where possible.					
Inspector Comments: Repair the vehicle erosion long the landside slope.

View of the vehicle erosion along the landside slope.

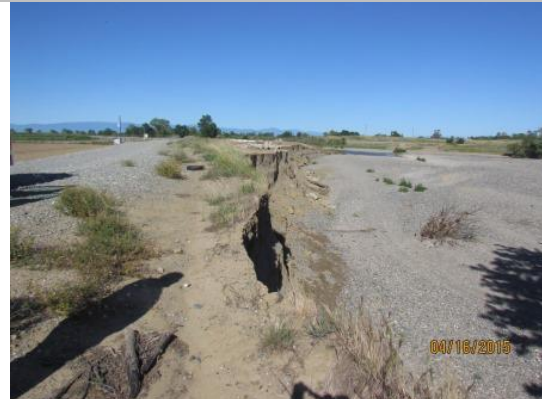
Photo 1 of 1 : FA\_2015\_NA0019\_82\_15\_20150910\_00004.jpg

LM Start	1.96	Rating **	U	Issue No.	15
LM End	1.96	Issue Type +	Ma	Location *	WS
Category	Earthen Levee			GPS Latitude/Longitude	
				Start	End
Item	Erosion / Bank Caving			40.052282 °	40.052282
				-122.157558 °	-122.157558
DWR ID	DWR_NA0019_05_s_2015_15				
Action/Comments					
Schedule repair of erosion site prior to the next inspection.					
Inspector Comments: Repair the erosion along the waterside slope.

View of the erosion along the waterside slope.

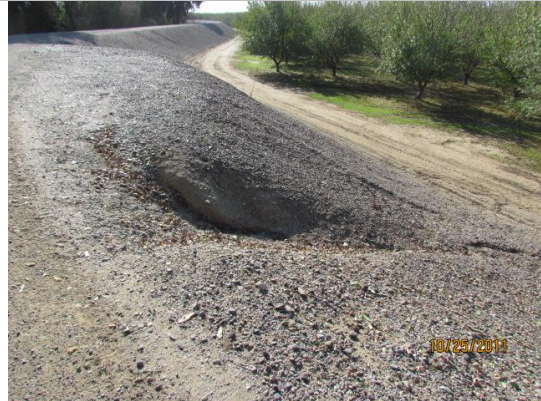
Photo 1 of 1 : FA\_2015\_NA0019\_82\_7\_20150910\_00002.jpg

LM Start	3.38	Rating **	M	Issue No.	7
LM End	3.38	Issue Type +	Ma	Location *	LS
Category	Earthen Levee			GPS Latitude/Longitude	
				Start	End
Item	Erosion / Bank Caving			40.056727 °	40.056727 °
				-122.134888 °	-122.134888 °
DWR ID	DWR_NA0019_05_s _ 2012_7				
Action/Comments					
Schedule repair of erosion site prior to the next inspection.

View of the erosion along the L/S slope.
